U. S. HIGHWAY 93 RECONSTRUCTION ON THE FLATHEAD INDIAN RESERVATION

Addressing Highway-related Habitat Fragmentation

Dale Becker, Tribal Wildlife Program Manager

Confederated Salish and Kootenai Tribes

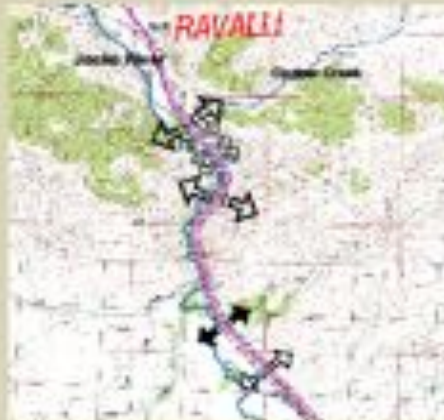
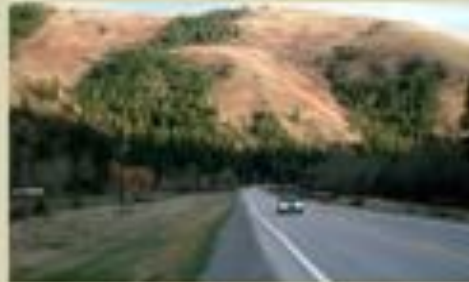
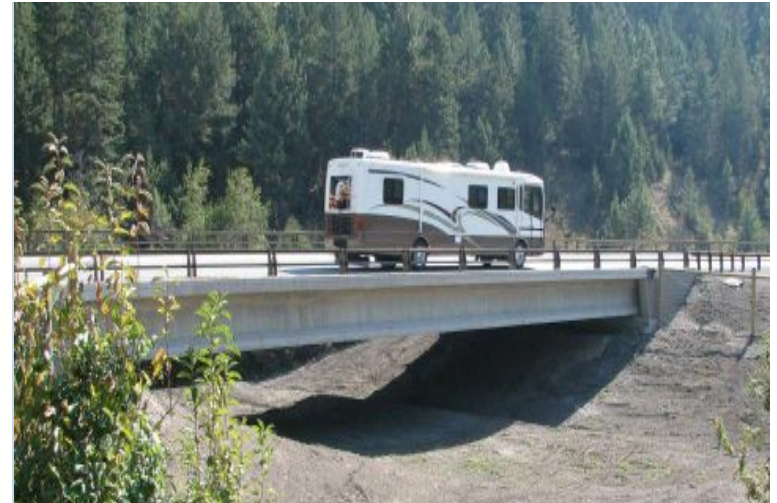
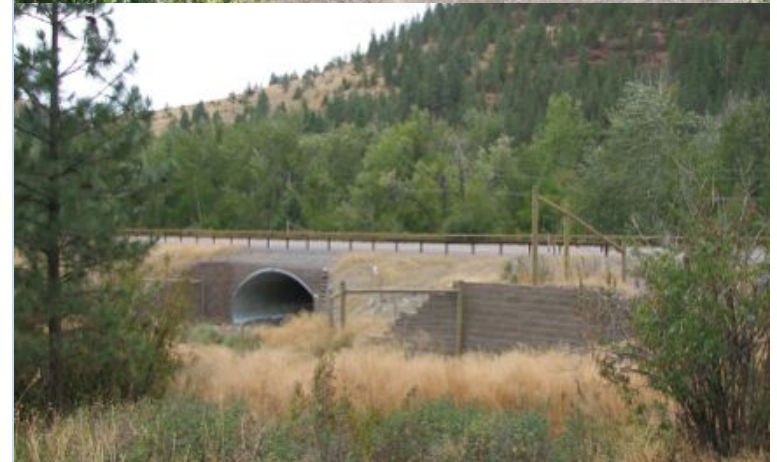
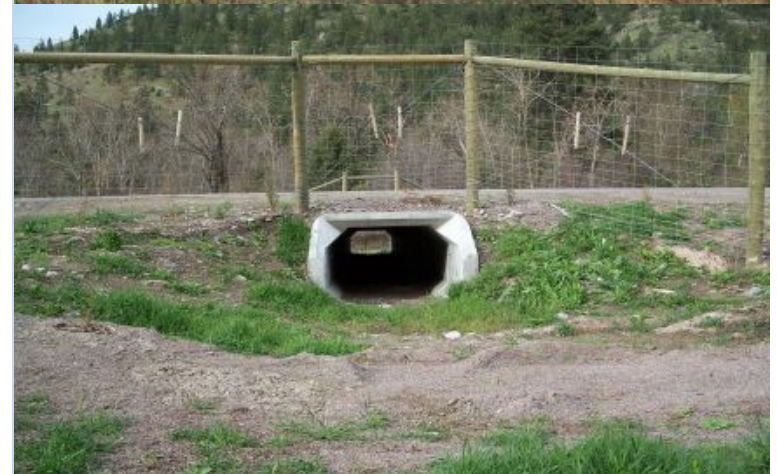
18. Ravalli Curves #2 Wildlife Crossing Arlee - Ravalli Segment

This area has great significance for fish and wildlife crossing. The Jocko River is bull trout bearing. Two tributaries in this area, Copper Creek and Spring Creek have been altered by highway fills and embankments. Restoring these water channels will greatly improve fish and wildlife habitat. Raising the road in concert with providing undercrossings, would improve motorist safety and allow wildlife to move through the canyon. Anticipated use by black bears, grizzly bears, mountain lions, bobcats, coyotes, elk, deer, etc.

Recommended crossing type: Corrugated metal pipe or concrete box culvert

Approximate dimensions: 12' x 22'

Continue 8' page wire fencing along both sides of road. Begin 8' page wire fencing south of Schall Flats #4 crossing; continue to a point south of Ravalli. Provide cattle guards for connecting roads and drive-ways. Fencing on west side of road to be placed below sight line.

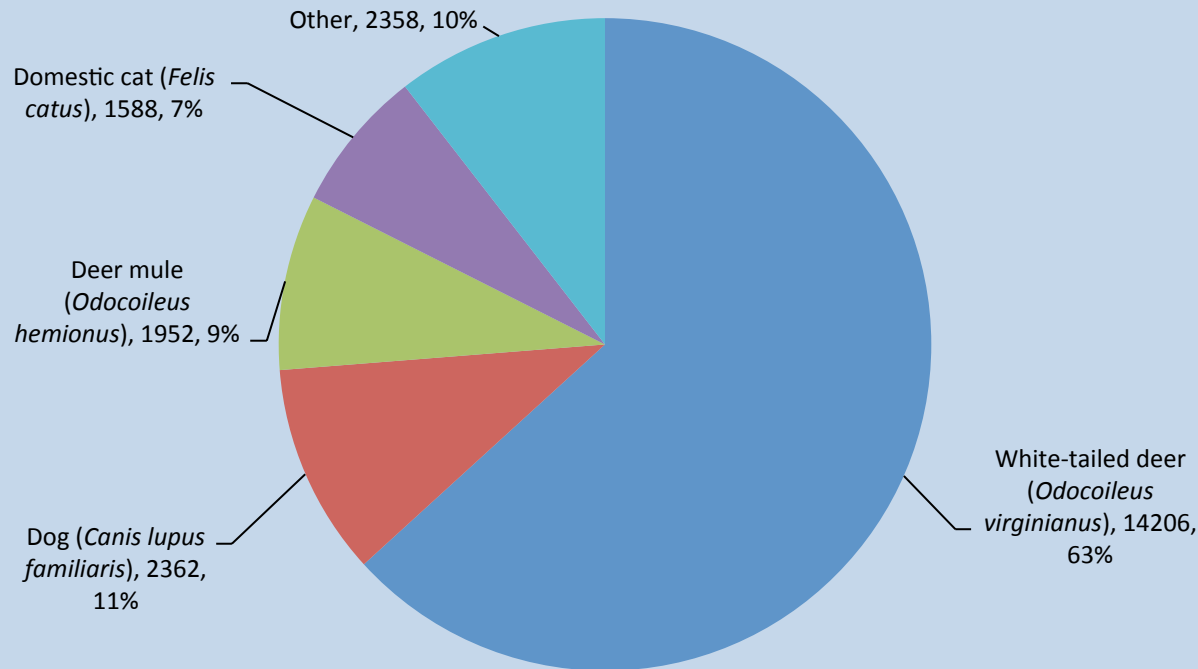
All Structures Monitored

Wildlife use of all the 29 wildlife crossing structures monitored in 2011 (December 31, 2010 – January 1, 2011). Preliminary data (N=22,466). From Huijser et al. 2012.
